# 2015 ANNUAL REPORT ON DRINKING WATER QUALITY

JAN.1 – DEC. 31 2015

## SYDENHAM WATER TREATMENT PLANT

*Drinking Water System Number:* 260069290

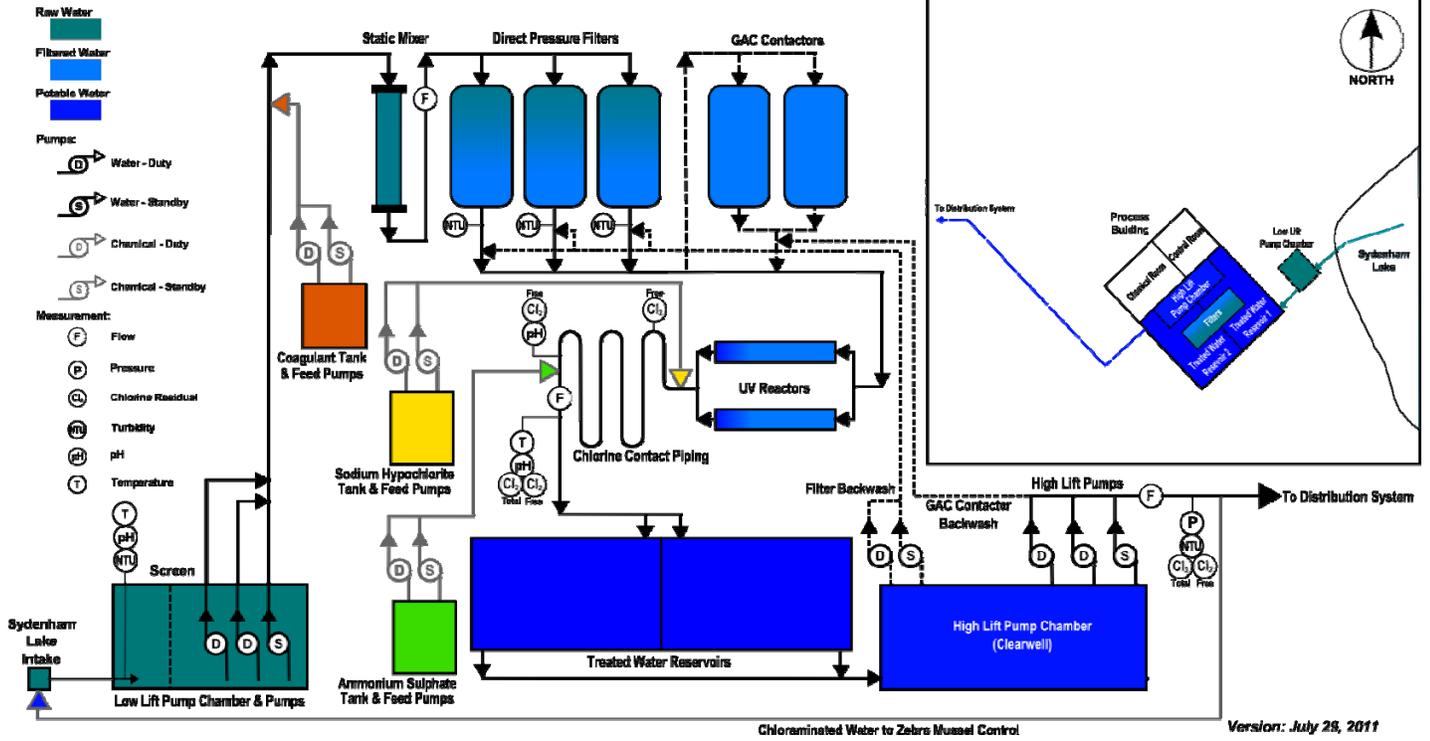
**SYDENHAM WATER TREATMENT PLANT PROCESS FLOW**

## 5. Flow Diagram

The source of water treated by this plant is Sydenham Lake. The intake is located 128m east of the treatment plant, at approximately 6m of water depth.

Pre-chlorination takes place at the mouth of the intake. This protects the intake from becoming encrusted with zebra mussels, which would restrict the flow of water through the intake.

Two stationary screens located in the low lift pumping well remove any large debris such as weeds, fish, etc.

These pumps lift the water from lake level to the main treatment building. There are three submersible pumps each with a capacity of 7.8 l/sec which pump the water into the main building for treatment.

XL1900 (Polyaluminum Chloride) is added to the water as it enters the process building just prior to passing through the in-line mixer. The particles in the water will collide with the PACl particles as the water flows in a spiral motion through the mixer, and then join together to form larger particles called floc.

Three pressure filtration tanks containing a ceramic filtration media remove the floc formed from the addition of PACl and the particles present in the water. Water flows through the filters into two baffled clean water reservoirs called clear wells.

Filters are washed to remove the particulates they have collected over the previous 48 hrs. Clean water from the clear well is pumped backwards through the filter, and the filter is agitated by air scouring the filter media to break up any large particles.

Effluent water from the backwash process is directed to a backwash storage tank for further settling. The supernatant (the clear water at the top of the tank after settling) is directed back to Sydenham Lake and the settled sludge is mechanically removed and sent for further treatment.

During periods of high dissolved organic content in the source water, filter effluent water is directed to two pressure filtration tanks containing granular activated carbon (GAC). The GAC contactors assist in the removal of dissolved organics which react with chlorine to produce chlorination by-products. The GAC contactors are periodically backwashed to remove the particulates they have collected.

Primary disinfection of the filtered water is achieved via UV light and free chlorine residual. 2 UV reactors (duty/standby) each using 12 low pressure high output lamps, provide the UV light disinfection. Free chlorine disinfection follows the UV process with the use of two chemical metering pumps (duty/standby) which provide sodium hypochlorite to an application point downstream of the UV reactors at the entrance to the detention piping.

Secondary disinfection is the maintenance of a disinfectant residual throughout the distribution system which is achieved with chloramines. Following the free chlorine disinfection process, ammonium sulphate is added with the use of two chemical metering pumps (duty/standby), at an approximate rate of 4:1 ratio (chlorine/ammonia), to react with the free chlorine residual to form chloramines. The application dosages of sodium hypochlorite and ammonium sulphate is adjusted to produce a sufficient in plant combined chlorine residual to ensure that minimum residuals are maintained in the distribution system.

Two baffled clear wells, each with a volume of 115 m<sup>3</sup>, provide storage of filtered water and allow for a sufficient amount of chlorine contact time with the water to ensure proper disinfection.

Three high lift pumps move treated water from the clear wells into the distribution system.
